| <b>SOUND SKULPTOR</b> | Title | MP32 Component Layout | Sch Rev | 1.2 |

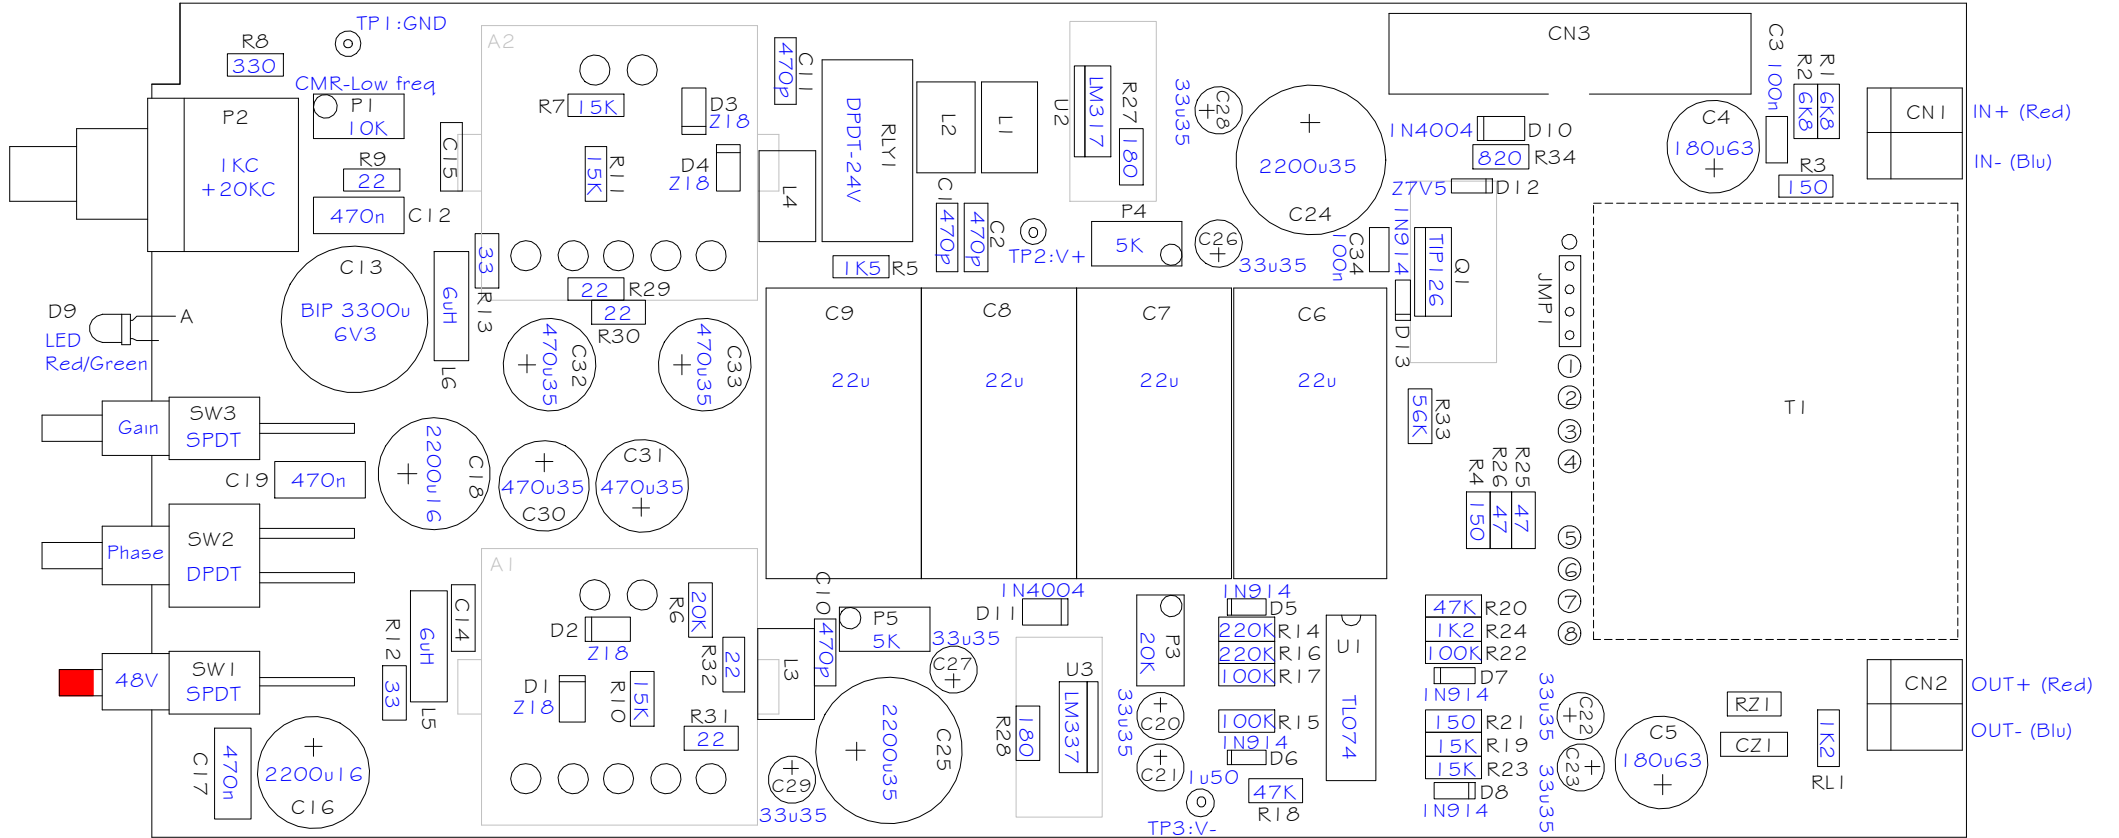
C14, C15 not connected in case of SK47 DOA, 47pF in all other cases

T1, RZ1, CZ1 : see mp32-output-tx-options.pdf
